Laser All-Ceramic Crown Removal—A Laboratory Proof-of-Principle Study—Phase 2 Crown Debonding Time

Peter Rechmann, DDS PhD,* Natalie C.H. Buu, DMD, Beate M.T. Rechmann, and Frederick C. Finzen, DDS
School of Dentistry, Department of Preventive and Restorative Dental Sciences, University of California at San Francisco, 707 Parnassus Avenue, San Francisco, California 94143

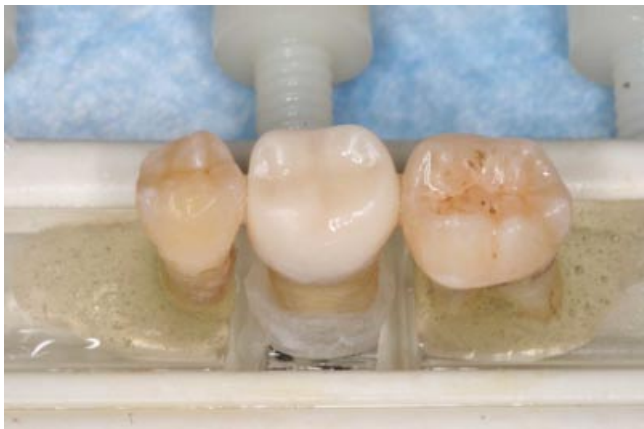
Fig. 2. Mounting sleigh for artificial row of teeth with adjacent teeth in place next to an E.max CAD crown.

Laser debonding of all-ceramic E.max CAD full contour crowns in an artificial row of teeth. All 20 Ivoclar E.max CAD all-ceramic full contour crowns that were cemented on single molars and then positioned in an artificial row of teeth were successfully laser debonded and removed. Figure 2 shows the mounting sleigh with the adjacent teeth in place (one bicuspid and one molar). The fixation screws are partially visible in the back.

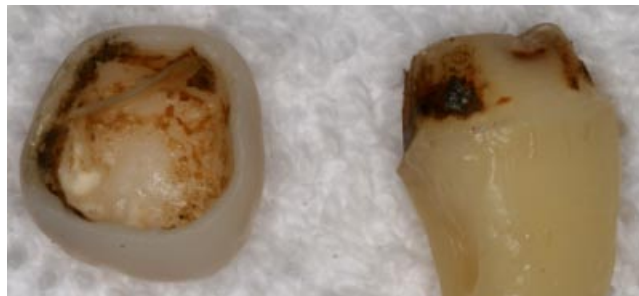
Fig. 3. ZirCAD full contour crown after laser debonding and removal. The pictures show the tooth from the mesial contact point side; No darkening of the cement at the contact points, slight darkening at the cement crown interface.

Laser debonding of all-ceramic ZirCAD full contour crowns (regular margins) in an artificial row of teeth. The average thicknesses of the full contour ZirCAD crowns (with regular cervical margins) was 1.89 ± 0.18 mm for occlusal, 1.6 ± 0.08 mm for buccal, 1.55 ± 0.05 mm for lingual, and 1.57 ± 0.07 mm for mesial and distal surfaces (average \pm SD). All 10 Ivoclar ZirCAD full contour crowns cemented on molars and then positioned in an artificial row of teeth were successfully laser debonded and removed. All ZirCAD crowns were removed in one piece and no crowns fractured during the debonding process. No changes in the underlying dentin were observed. Figure 3 shows a ZirCAD full contour crown after removal. The contact points received less laser energy and the cement is deteriorated, while the other areas received more energy and show slightly carbonized cement at the cement/crown interface.
